Safety Alert

Impact Protection Vehicle Cone Well Cover Failure

21 May 2024

IPV Cone Well Cover Failure

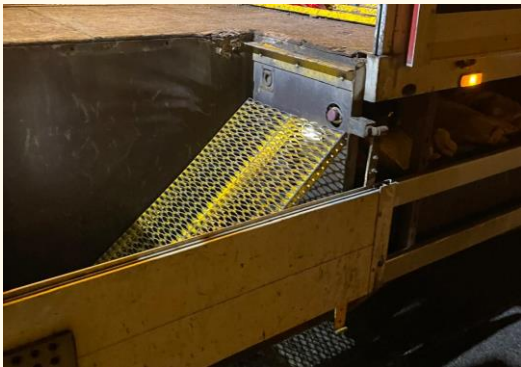
An agency operative working on his company supplied IPV suffered a trapping injury to his ankle due to the cone well cover collapsing and trapping his ankle against the structure of the vehicle.

The cone well cover was missing the hinges which connects the cover to the IPV body structure, and as there was no other mechanic means fixing the cover to the body, it fell into the well area below the bed of the vehicle.

The investigation identified that the cone well was in a poor state of repair. The defects with the cone well had not been reported at any time prior to the incident through the vehicle pre-use check process, or through periodic vehicle inspections undertaken by third party maintenance companies.

The vehicle involved was 9 years old, and whilst maintained in a roadworthy condition, there were no considerations given to the elevated risk of component failure on ageing assets.

- ✓ The condition of Cone Well covers must be regarded as safety critical similar to other types of work at height platform and have suitable inspection and maintenance regimes in place to ensure that they are safe to use.
- ✓ Vehicle Pre-use checks should include cone well covers as a specific checklist item and not to assume that they are being checked under general items such as the condition of the floor or body.
- ✓ Those in control of fleet need to consider the risks from use of ageing vehicles and mitigate the increased risks of fatigue or component failure through more frequent and vigorous inspection and maintenance regimes.
