# Safety Alert

## Damaged Impact Protection Vehicle Cone Well Cover

12 June 2024

## Damaged IPV Cone Well Cover

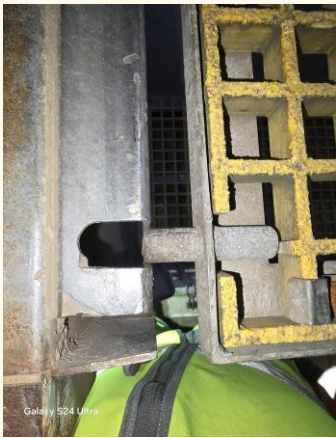
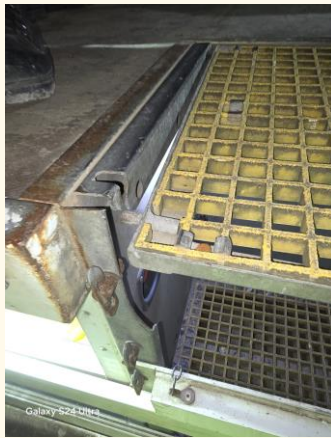
An TM operative working on an IPV suffered an injury to his ribs when the cone well he was standing on dropped into the cone well.

Inspection of the cone well cover found that it was bent in the middle, most likely caused by a forklift when loading and unloading the vehicle with equipment.

The bend in the cover had the effect of increasing the gap between the cone well cover securing pins and socket in which they sit when the cone well is in place.

As the operative was working on the cone well, the securing pin became free of the socket causing the cone well cover to drop.

The defect had not been reported whilst conducting pre-use checks or periodic vehicle inspections carried out by third party maintenance companies.

- ✓ Review how vehicles are loaded and unloaded by mechanical handling equipment and if loading and unloading can take place away from cone well areas on the vehicle bed.
- ✓ Vehicle Pre-use checks must include a thorough inspection of the cone well covers to ensure they are fit for purpose and safe for use.
- ✓ Any defects involving bent/damaged coning well covers must render the vehicle “out of service” and be reported immediately for repairs to be made.
